CONSTRUCTION: A Good Idea, or Are We Asking for Trouble?

By Derek A. Hodgin, RBEC, PE, CCCA

A version of this article was presented to the Forest Products Society International Conference in June 2017.

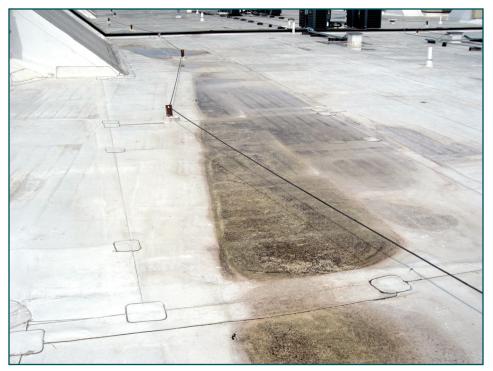
Figure 2 – Typical ponding where the valley of a roof cricket is less than ¹/₄ inch per foot.

Wood will permanently deform when overstressed for an extended period of time. This phenomenon, known as creep, can be particularly important for the long-term performance of low-slope roofs.4 The building code has long required a minimum slope of ¹/₄ inch per foot. Even when complying with this requirement, ponding occurs along the valleys of roof crickets that have a slope less than 1/4 inch per foot (Figure 2). This slope is further reduced when wood roof trusses deflect under the load of HVAC units. This can be a self-perpetuating problem. Once the slope is lost and water begins to pond, overstress and associated creep occur. At that point, the best case is that a roof leak develops and gives notice to the occupants of a problem. The worst case is a roof collapse.

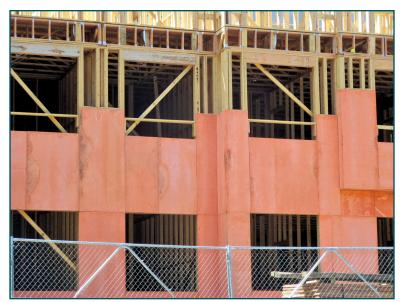
Figure 6 – Typical ordinance-driven architectural details that require walls to have "reveals" in exterior walls, creating numerous inside/outside corners.

In order for these larger buildings to have architectural appeal (and not just be a plain wood box), many local ordinances require exterior walls to include setbacks or reveals (*Figure 6*). By moving the walls in and out, numerous inside and outside corners are created. These corners require attention to detail properly. Specifically, the drainage plane (typically consisting of components such as a weather-resistive barrier [WRB], self-adhered flashing [SAF], liquid-applied waterproofing, and metal flashing), needs to be constructed in a manner that provides continuity.⁷ An open gap, joint, or unsealed and/or reverse lap can, and often does, lead to significant water-related damage.

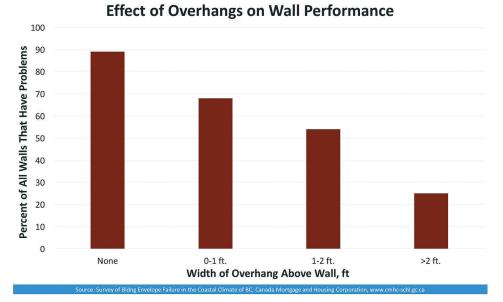
Figure 9 – Correlation between lack of roof overhang and water damage.

There is a direct correlation between the extent that a roof overhang exists and water damage to exterior walls (*Figure 9*). This would be a meaningful architectural discussion to have on all new construction projects. The more protection we can provide, the longer the building will last! ed, many times the symptom is dealt with instead of the cause. If water intrusion is observed, the damaged area may be repaired and some exterior caulk applied to prolong the reporting of the next problem. This cycle can serve to significantly increase the extent of damages, sometimes to the point that structural integrity can be compromised and the interior building conditions (i.e., mold growth and air quality) can be a health risk to the occupant. This is not to suggest that owner-occupied mid-rise condominium buildings are not problematic; however, when the occupant has "skin in the game," an appropriate and comprehensive response to a problem is more likely.

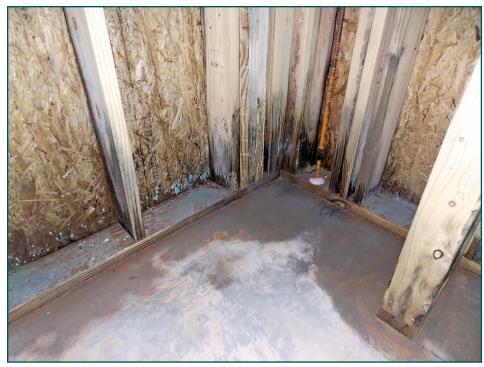
Figure 10 – Water intrusion/damage of a mid-rise wood-frame building under construction.

Since many of these buildings provide student housing, an accelerated and sometimes unrealistic construction schedule may be pushed onto the construction team. Most often, regardless of when construction commences, there is a desire for occupancy in August of a given year, corresponding with the beginning of the fall semester for most universities. The attempt to condense the schedule can create inappropriate sequencing of trades that allows water intrusion to begin before construction is even near completion (*Figure 10*).

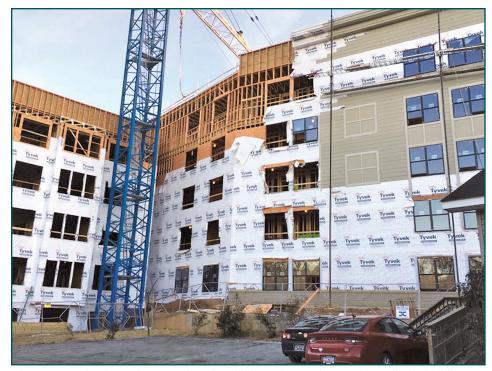
Figure 11 – A haphazard sequencing of multiple trades on the exterior wall of a building under construction.

Specifically, instead of an orderly sequence of framing, WRB installation, window installation, and cladding installation, contractors will have a haphazard combination of multiple trades on the building—all at the same time, creating easy opportunities for water to be trapped in the exterior wall assembly (*Figure 11*). In some cases, significant water intrusion repairs are needed before the construction is even completed.

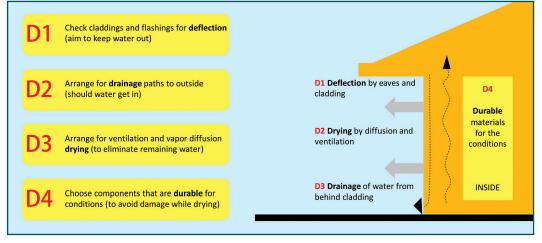
Figure 12 – The Four Ds of Wall Design.

building must be durable and not sensitive to moisture. The entire path that the water follows must be protected and free from "alternate paths" created by gaps, openings, reverse laps, etc. that could allow water to penetrate to deeper, unprotected locations where hidden damage can develop. In general, the shorter the path, the better. The less dwell time the water has on building surfaces, the better the wall will perform. The basic exterior wall design concepts for improved durability are often referred to as the four Ds (Figure 12):
